# NASA TECHNICAL MEMORANDUM

NASA TM-78187

## SRB MATERIALS AND PROCESSES ASSESSMENT FROM LABORATORY AND OCEAN ENVIRONMENTAL TESTS

Materials and Processes Laboratory

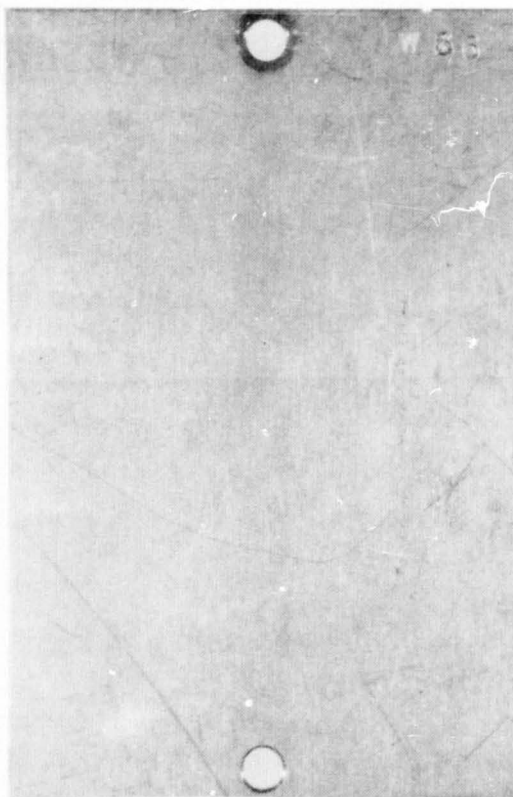
b. Results. Results of this test showed heavy corrosive attack and marine growth on the bare 2219 aluminum alloy exposed to both ocean and bay environments, with the heaviest being on samples exposed in the bay (Fig. 11). The alodined panels had light to medium corrosion over the surfaces while the anodized panels were unaffected (Fig. 12). The paint coating used for this test was a "Cat-A-Lac" epoxy coating which incorporated a chromate inhibited primer. In general, the coating afforded good protection to the aluminum surfaces; however, some corrosion was noted in the scribe mark (Fig. 12). Both the Inconel and titanium bare alloys were completely free of corrosion and biofouling (Fig. 11). Although some corrosion on the bare aluminum could be attributed to galvanic action when coupled with the titanium or Inconel 718, the amount was not significant because the rest of the bare aluminum corroded so rapidly. No evidence of galvanic action was noted on the painted aluminum when coupled to the other alloys. The samples exposed to the synthetic seawater in-house were considerably less affected than those exposed to the ocean. Considerably less corrosion was noted on the bare aluminum samples. Also, it should be noted that synthetic seawater tests cannot evaluate any effects caused by biofouling because of the absence of marine organisms.

Figure 11. First Gulf of Mexico test — uncoated panels exposed in the bay for 7 day

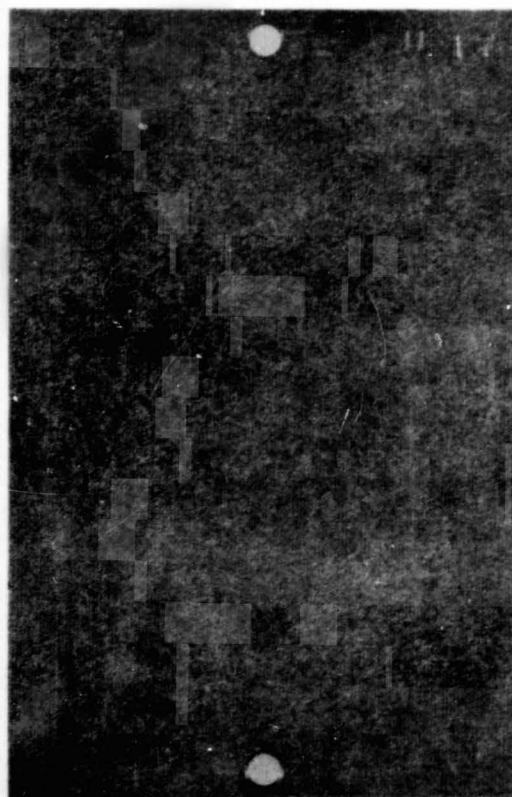
Figure 12. First Gulf of Mexico test — coated panels exposed in the bay for 7 days.

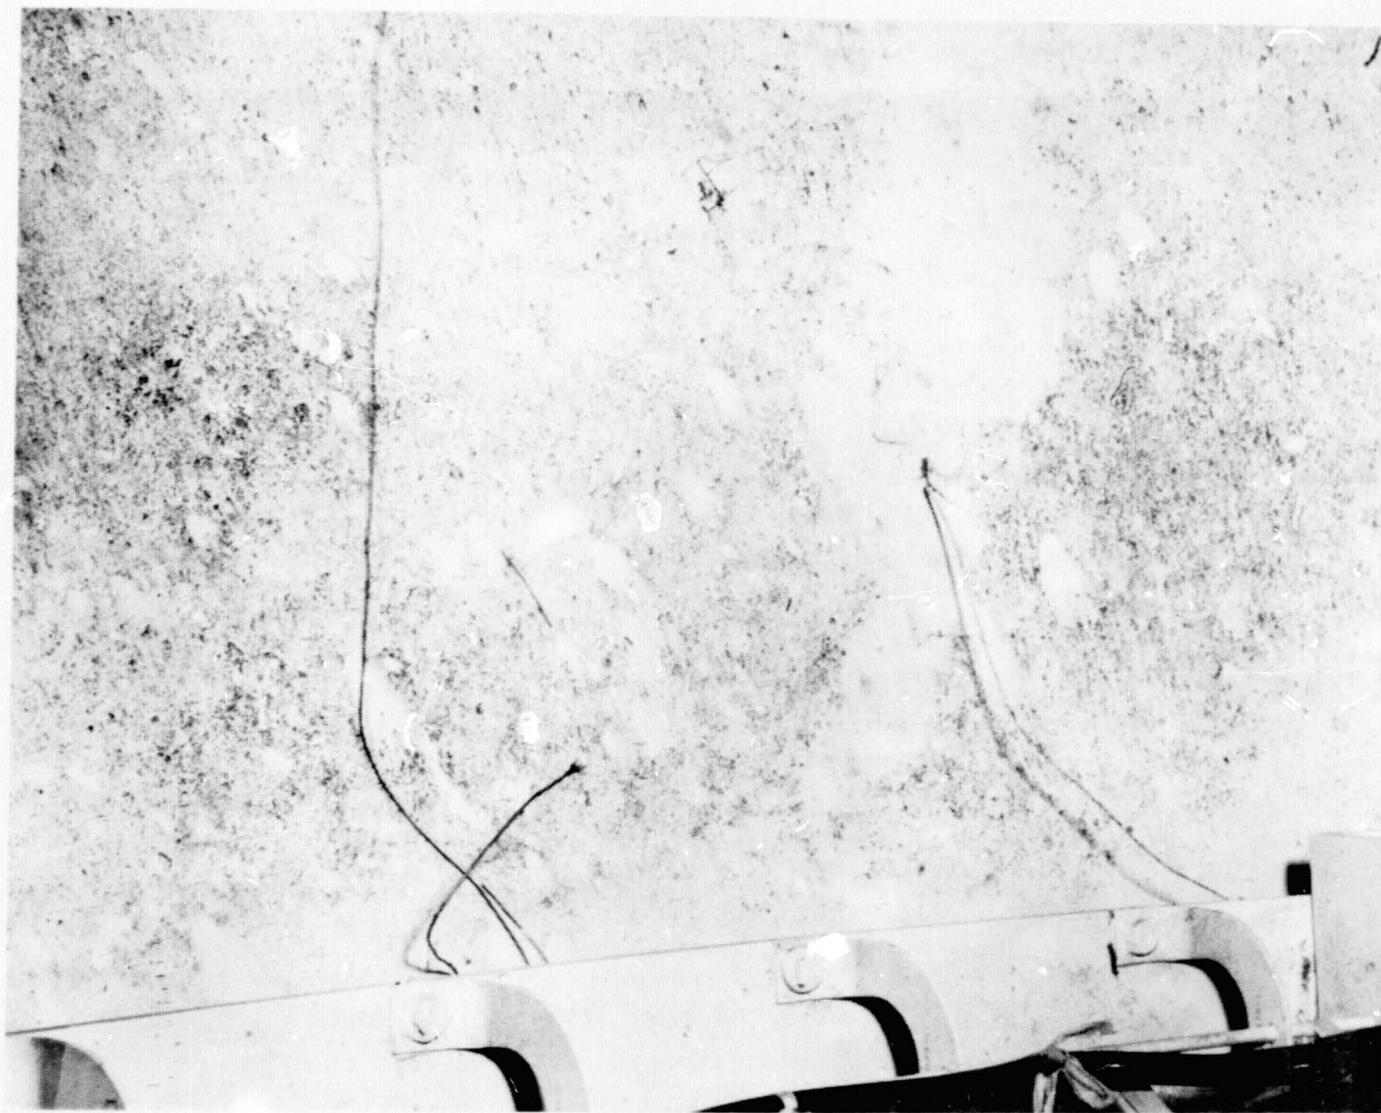
Figure 32. Dirt and soil on surfaces of ITB after exposure to ocean and river.

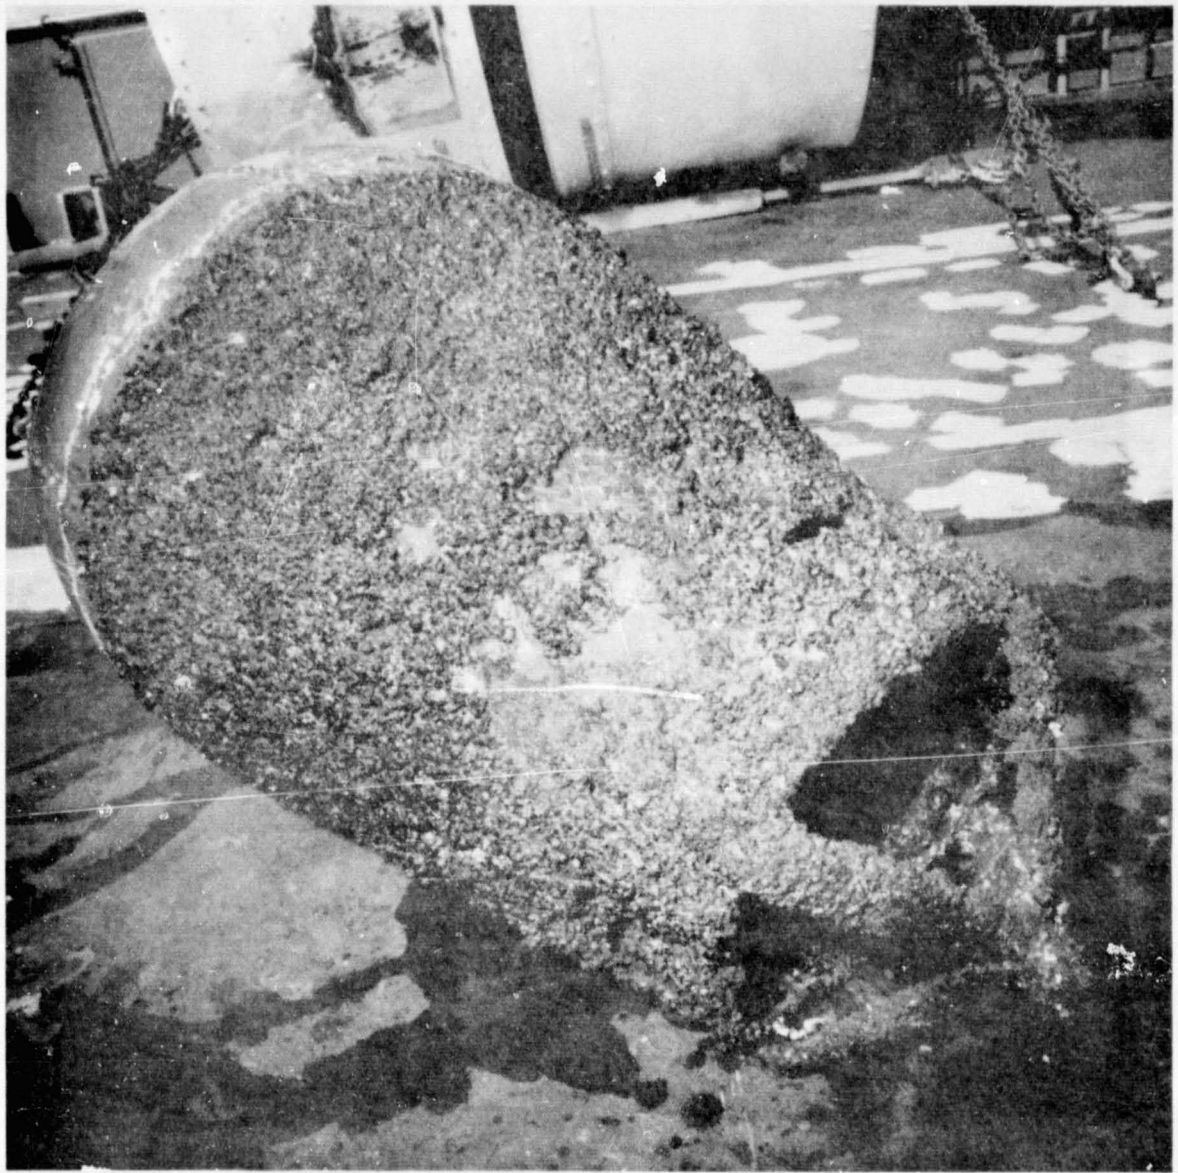
In the laboratory, pure cultures were isolated onto new appropriate marine media. The Shewan Scheme of differentiation was again used for microbial general identification. It was found from the water samples that the microbial population had more than doubled in both the ocean and dock site since the last exposure testing (January 1976). This is normal, as some marine organisms double their populations with each 10 degree rise in temperature. The same general types of organisms were found: achromobacter, flavobacterium, pseudomonas, vibris, and seromonas. Panel 4 (MSA-1 coated with Hypalon — uncharred) carried the greatest mixed cultures with all of the previously mentioned organisms present. This indicates that panel 4 is a good general nutrient. Photos of rodac plates of ocean test cultures are shown in Figure 70. It was also noted on arrival at MSFC that panel 4 had bleached a lemon color in its container of seawater. In addition to microbial growth, the ITB was found to have attracted shrimp, barnacles, slime mold, fungi, and algae during this exposure test. Some photos of damages and accumulations are shown in Figures 71 through 74.

Figure 72. Typical accumulation of barnacles on buoy  
after 5 months exposure.

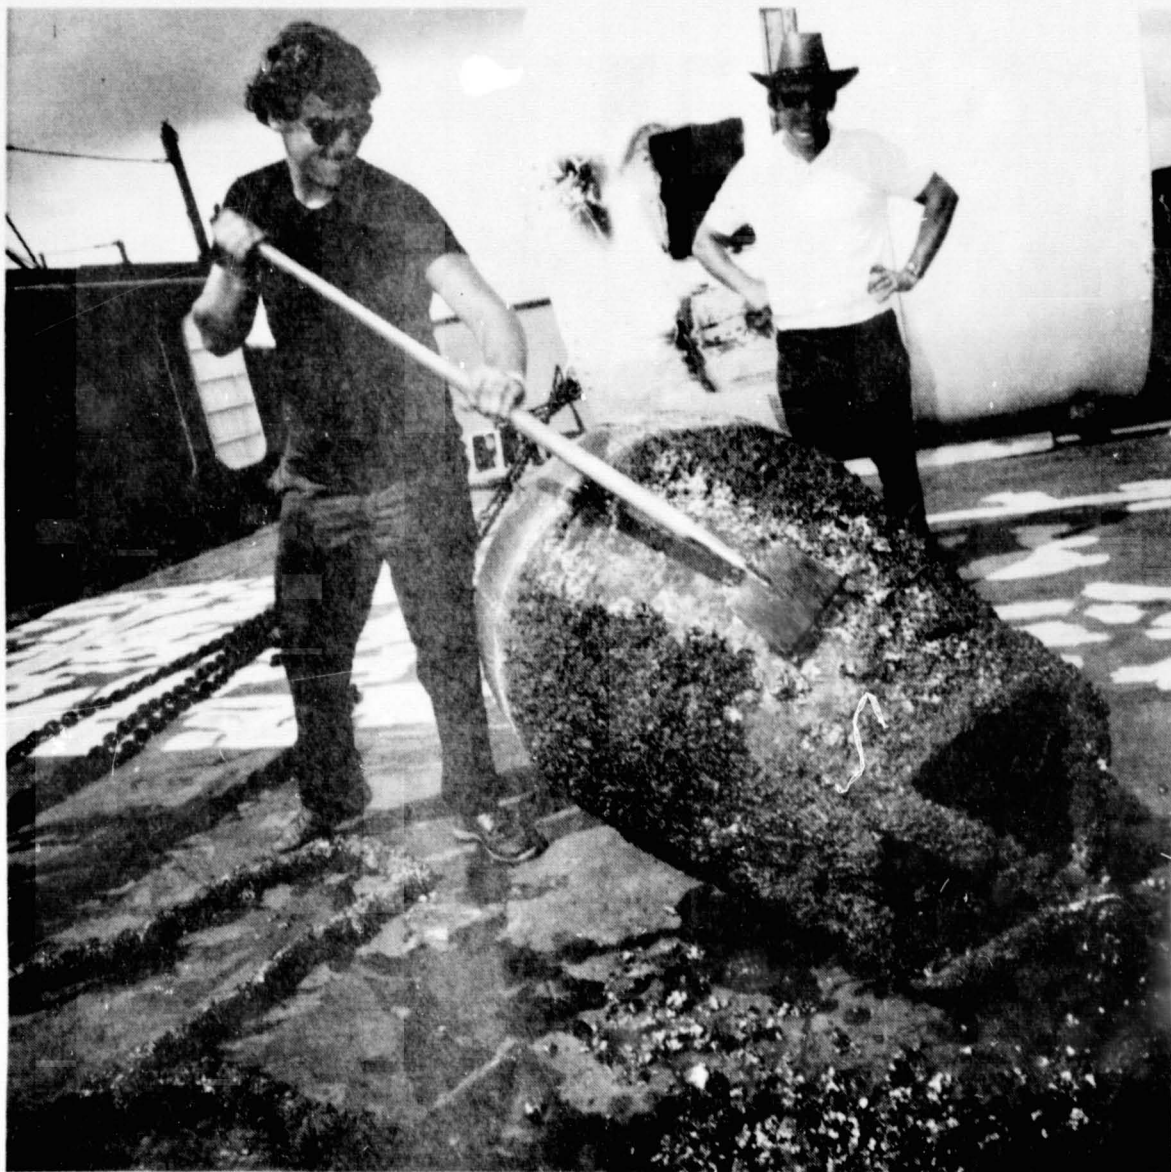
Figure 73. Removal of barnacles from buoy.

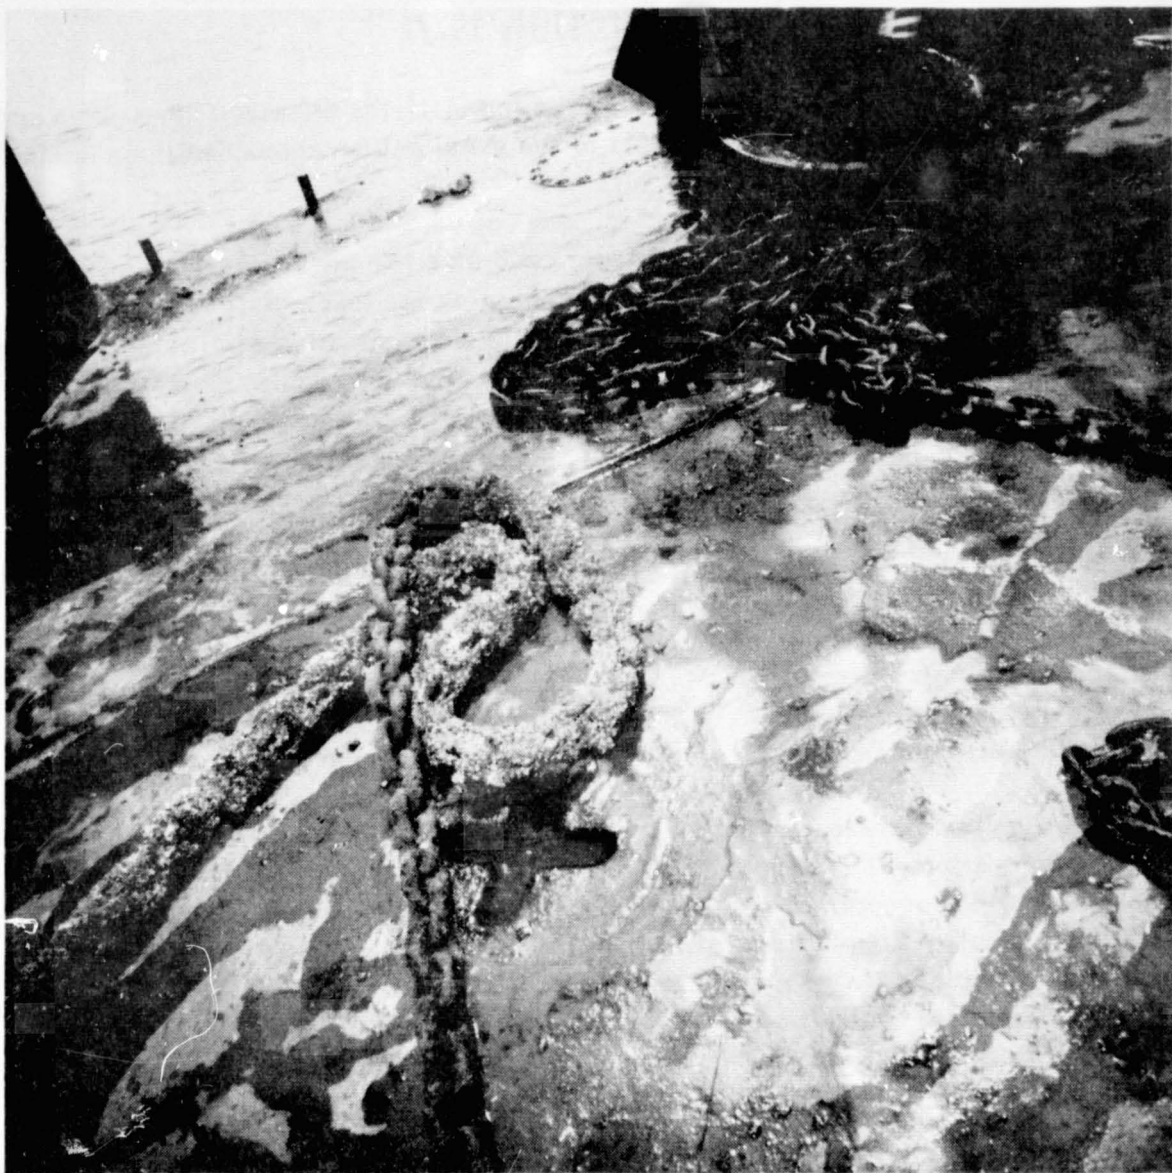
Figure 74. Barnacles on buoy chain.

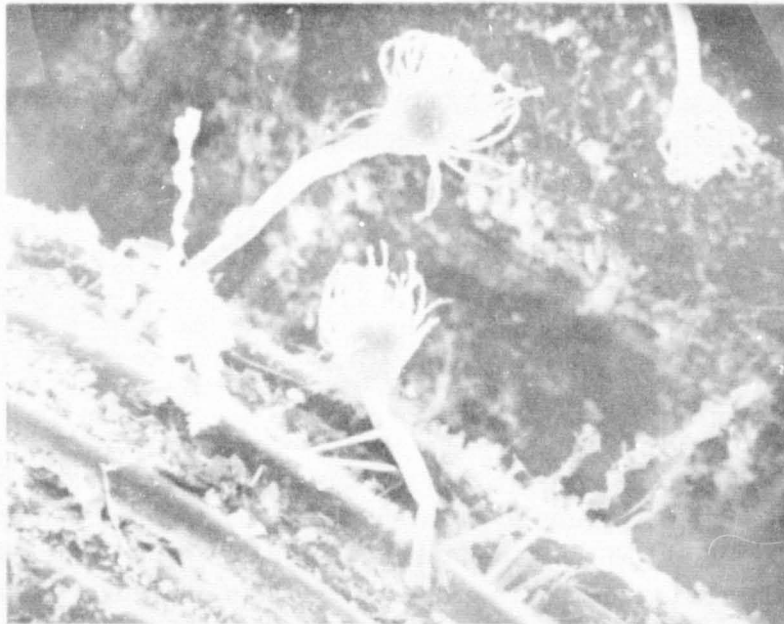
Figure 82. Hydroids on parachute material (EH 33-3) after exposure for 7 days to ocean water (235X).

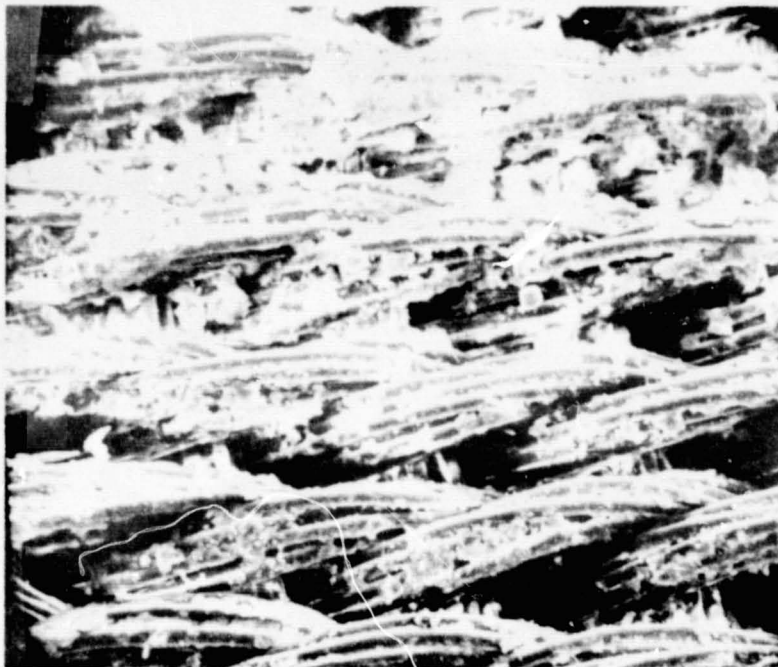
Figure 83. Organic material remaining after distilled water wash of the surface of the parachute material (EH 33-3) exposed for 7 days in the ocean and stored 7 days prior to washing with distilled water (107X).

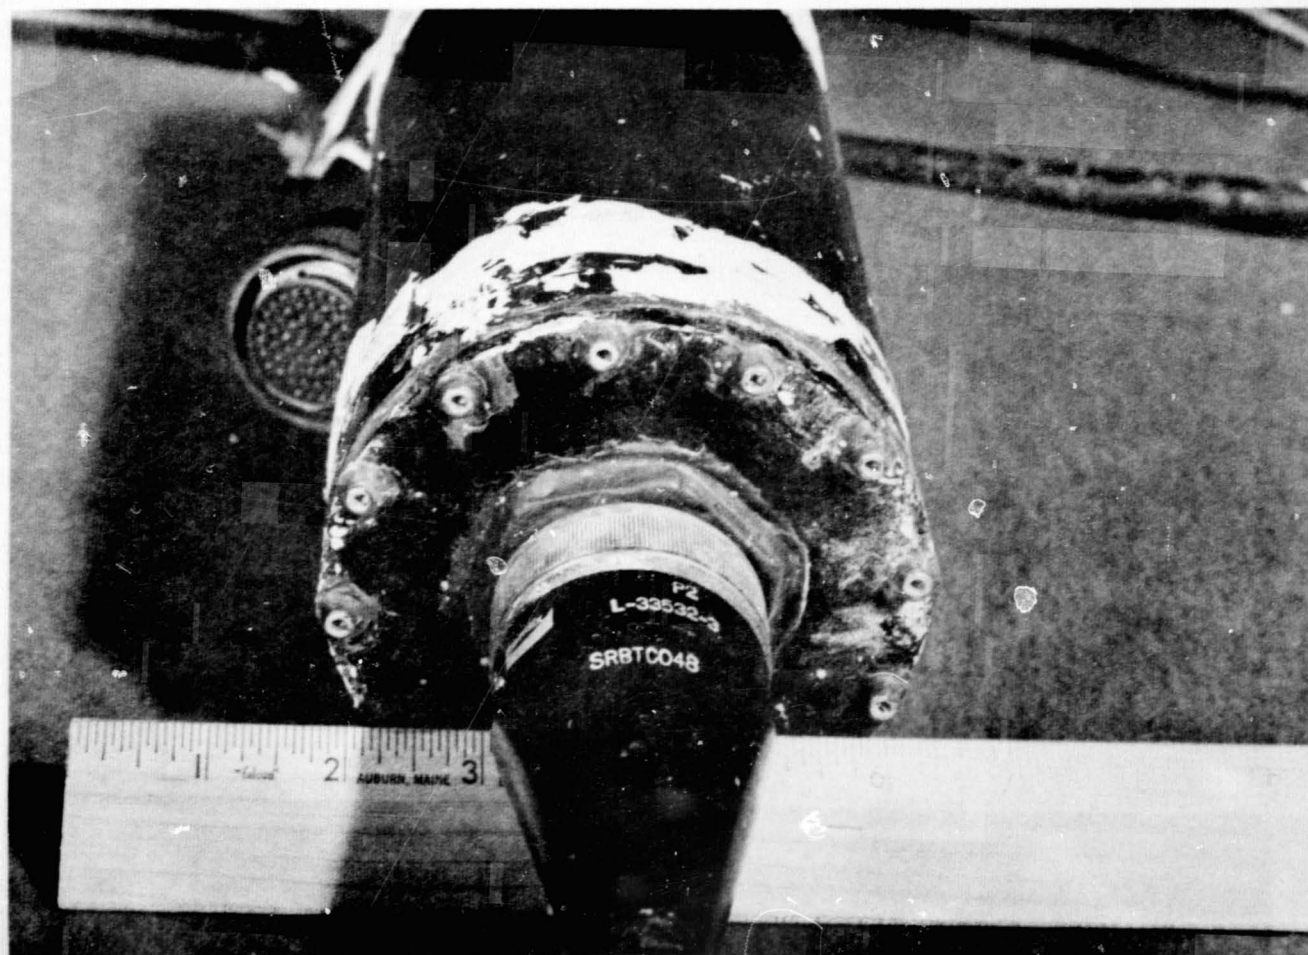
Figure 98. SRB watertight black box/cable assembly No. 2 after ITB testing (note corrosion around screw heads).

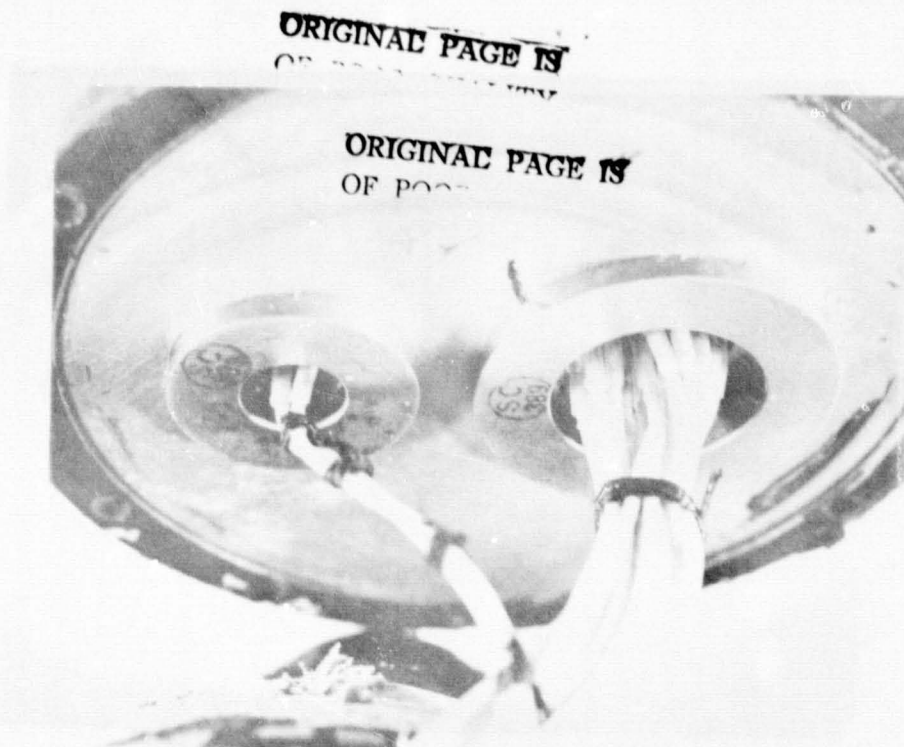
Figure 99. SRB watertight black box/cable assembly No. 2 after ITB testing (inside end plate).

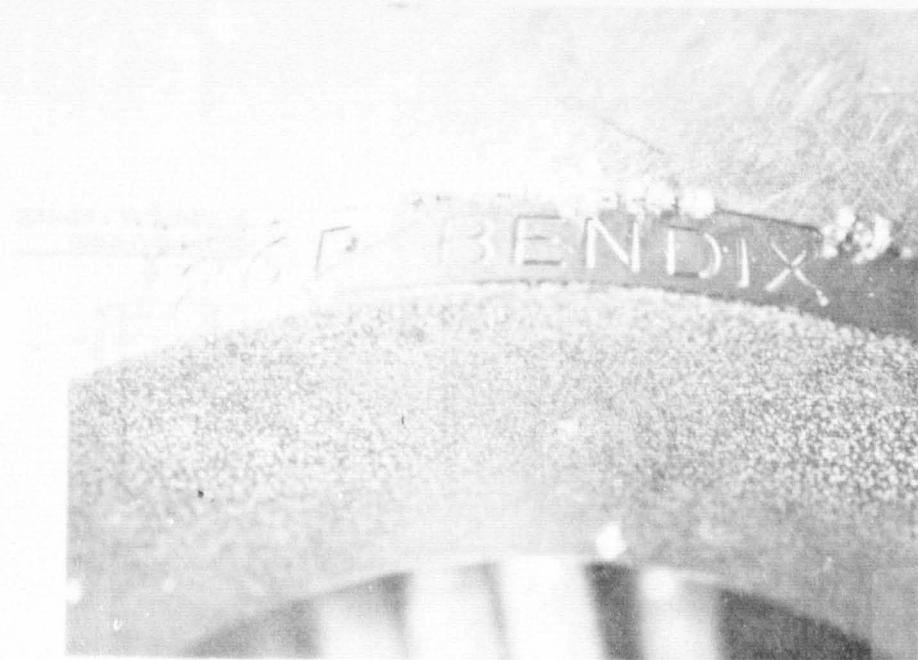
Figure 100. SRB watertight black box/cable assembly No. 2 after ITB testing (inside end plate, closeup).

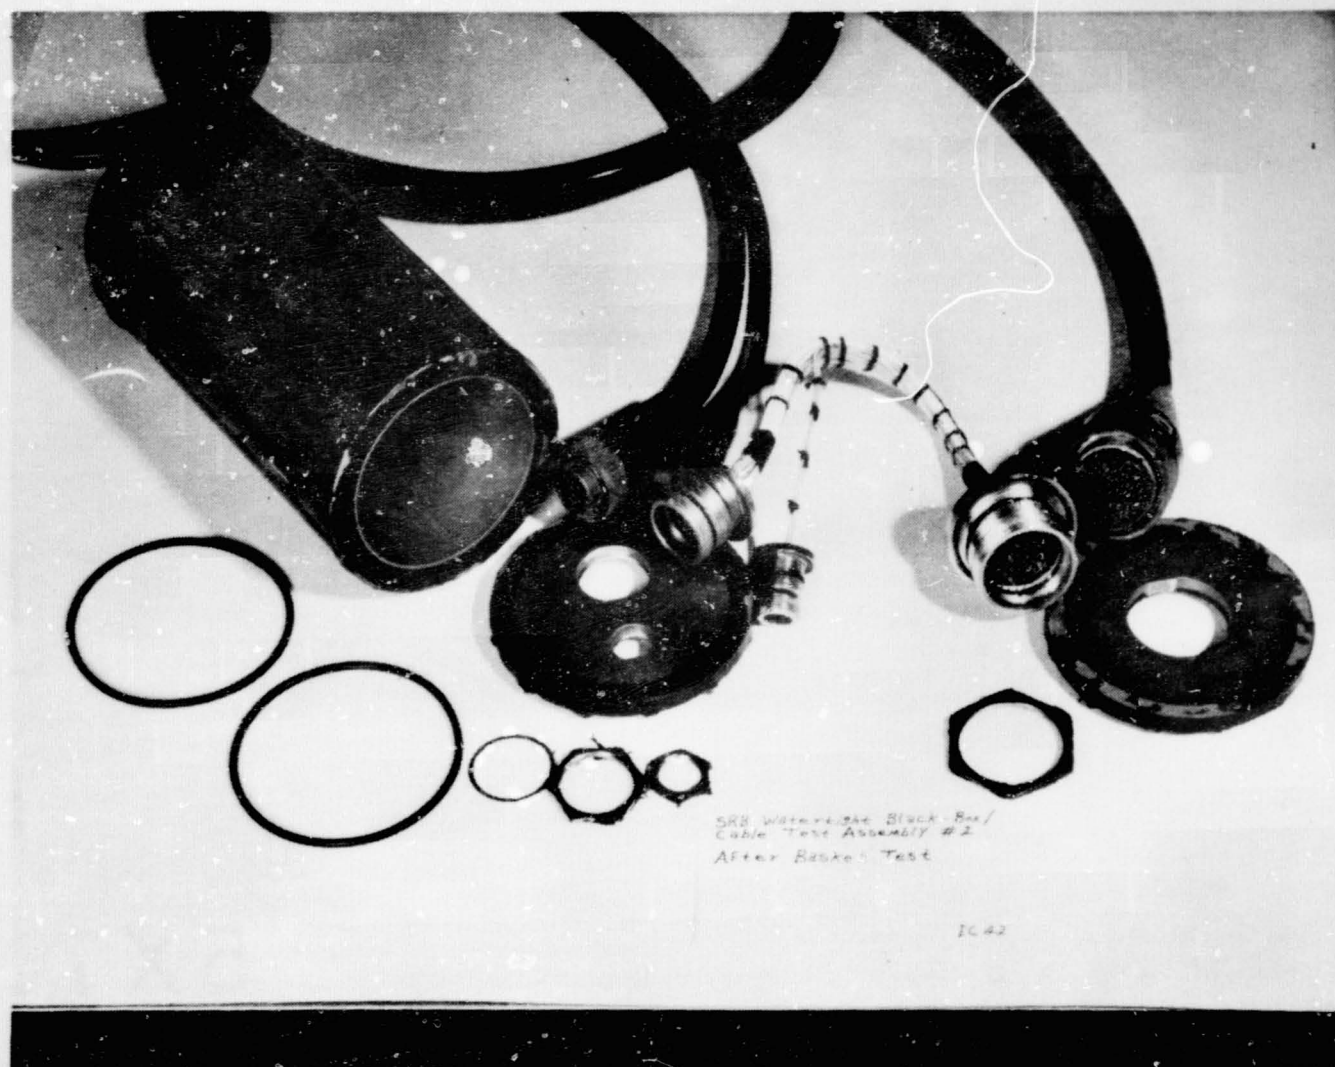
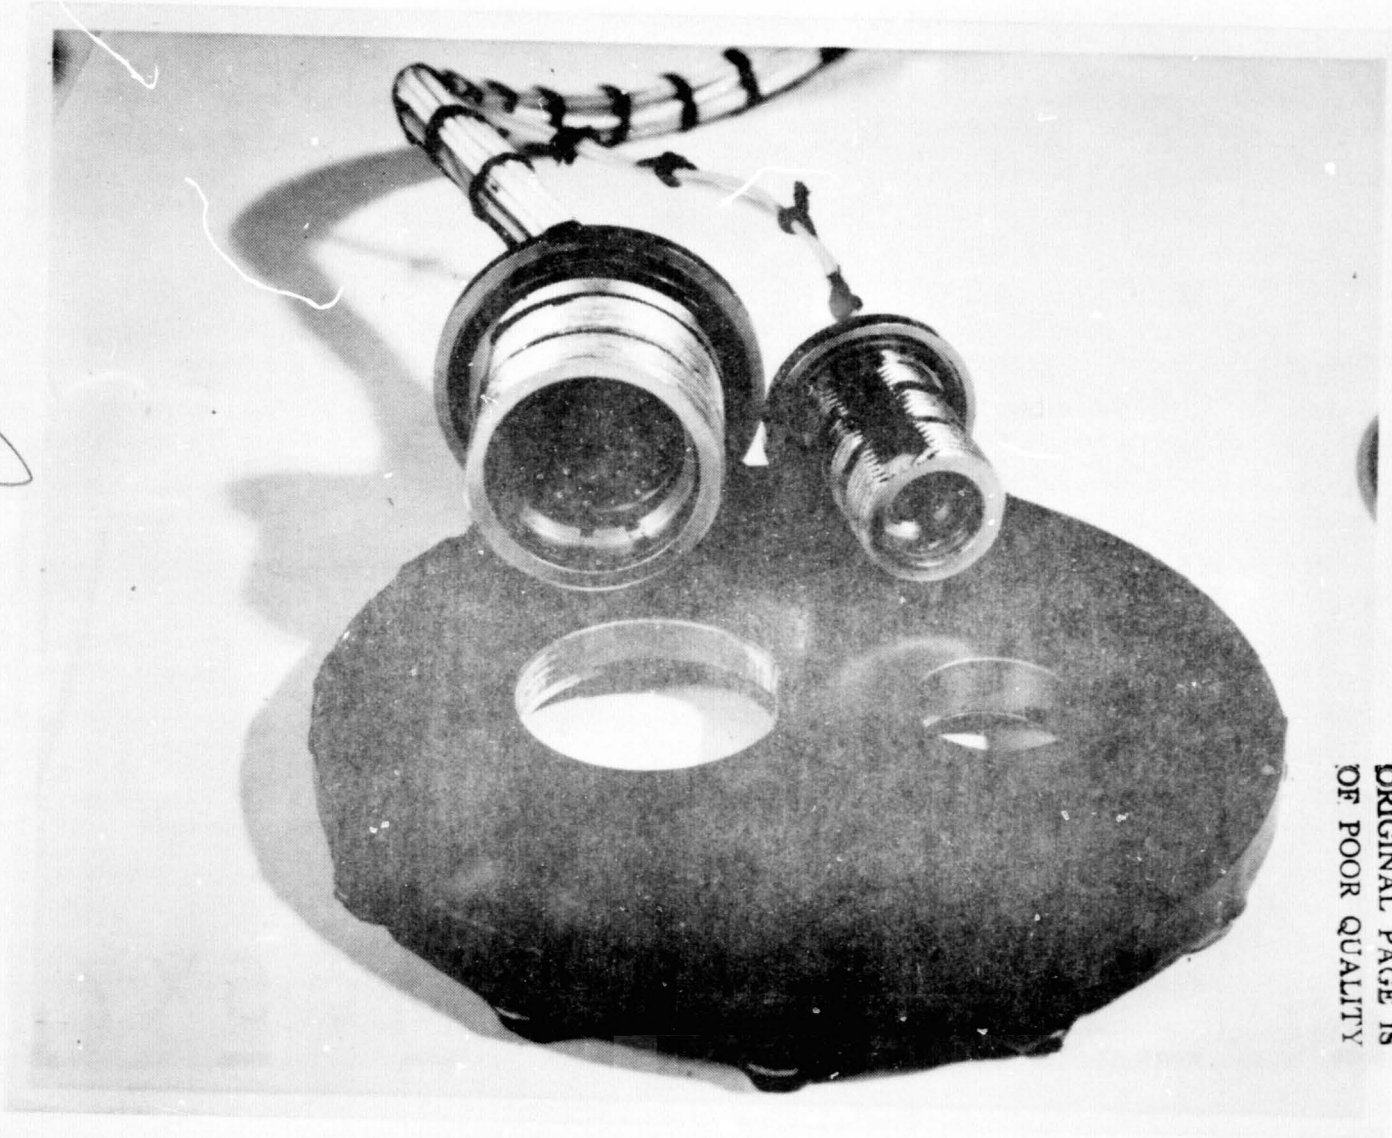
After being subjected to the basket test, there were no insulation resistance failures of the test article (all readings above 20 000 M $\Omega$ ). The outside of the test article was in good condition except a few spots where the paint was scraped off due to handling and strapping into the basket (Fig. 105). Very little corrosion was observed. However, with longer exposure serious corrosion probably would have developed in the spots where the paint was scraped off. There was no evidence of leakage to the inside of the connector mounting holes, inside the box, or connector interfaces. Sealant was observed in and around the outside edge of the connector mounting holes and in some of the connector threads. This resulted from use of the improved sealing technique (Fig. 105). No evidence of any damage or degradation of either the silver plated or nickel plated harness wires was observed.

Figure 105. SRB watertight black box/cable test assembly No. 2 after basket test.
